Report 300-2

**MAN-MADE CUTOFFS ON THE LOWER MISSISSIPPI
RIVER, CONCEPTION, CONSTRUCTION,
AND RIVER RESPONSE**

March 1977

U. S. ARMY ENGINEER DISTRICT, VICKSBURG

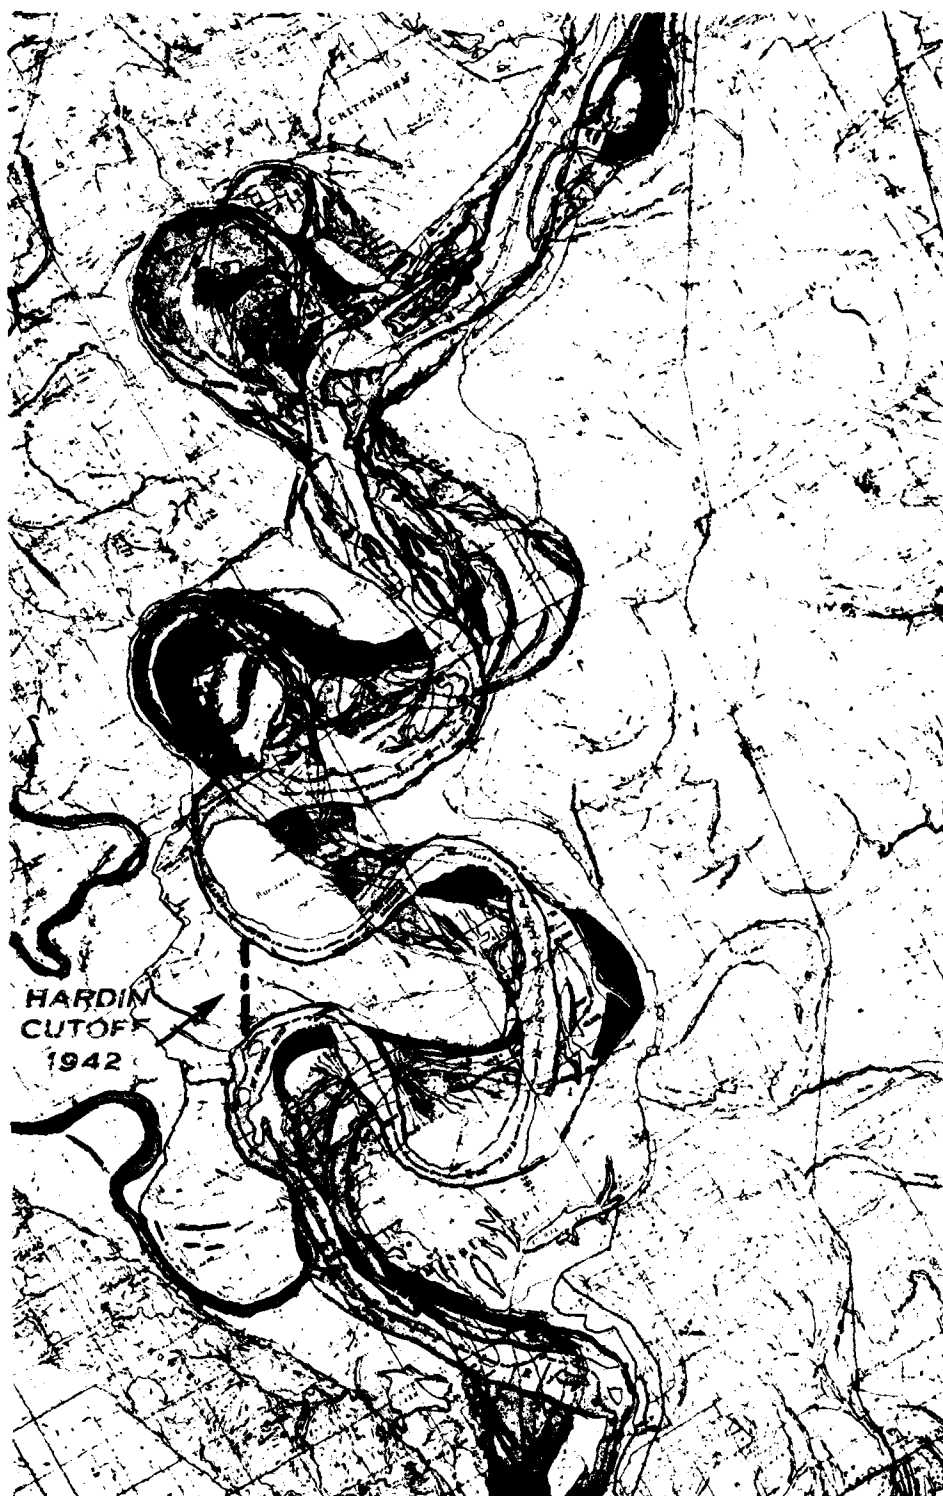
Figure 17

Figure 12 shows several surveys of the historic river in the vicinity of Hardin Point Cutoff superimposed. Figure 13 presents today's river with the revetment and dike construction. Historically, the river

HISTORIC DEVELOPMENT OF THE HARDIN POINT REACH

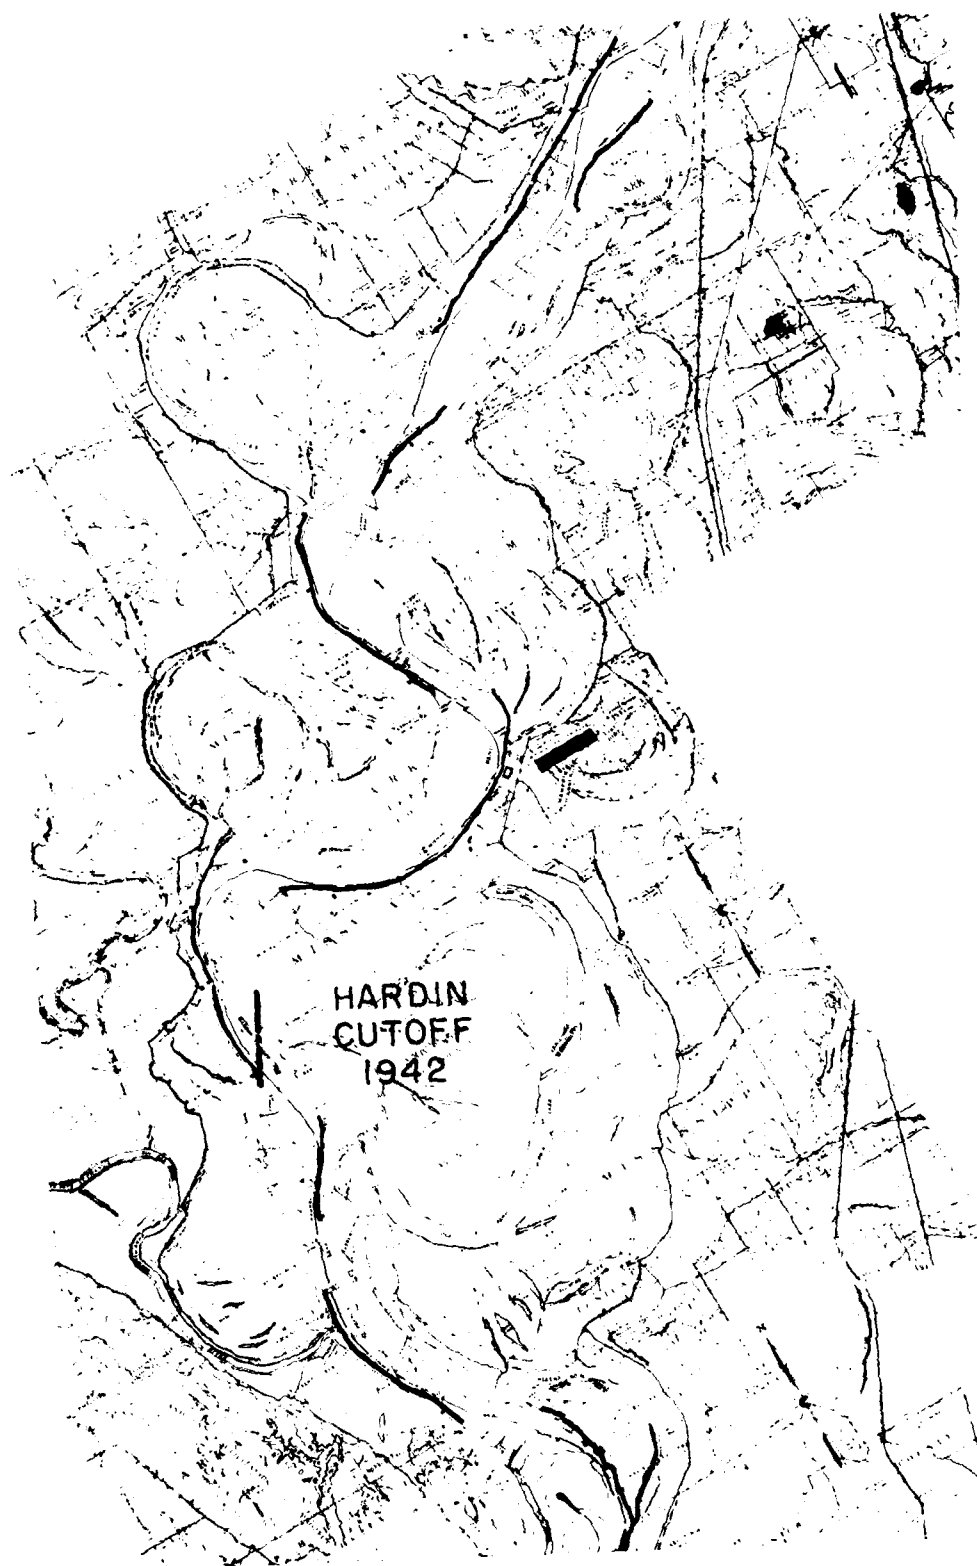
1975 MISSISSIPPI RIVER IN THE HARDIN POINT REACH Figure 13

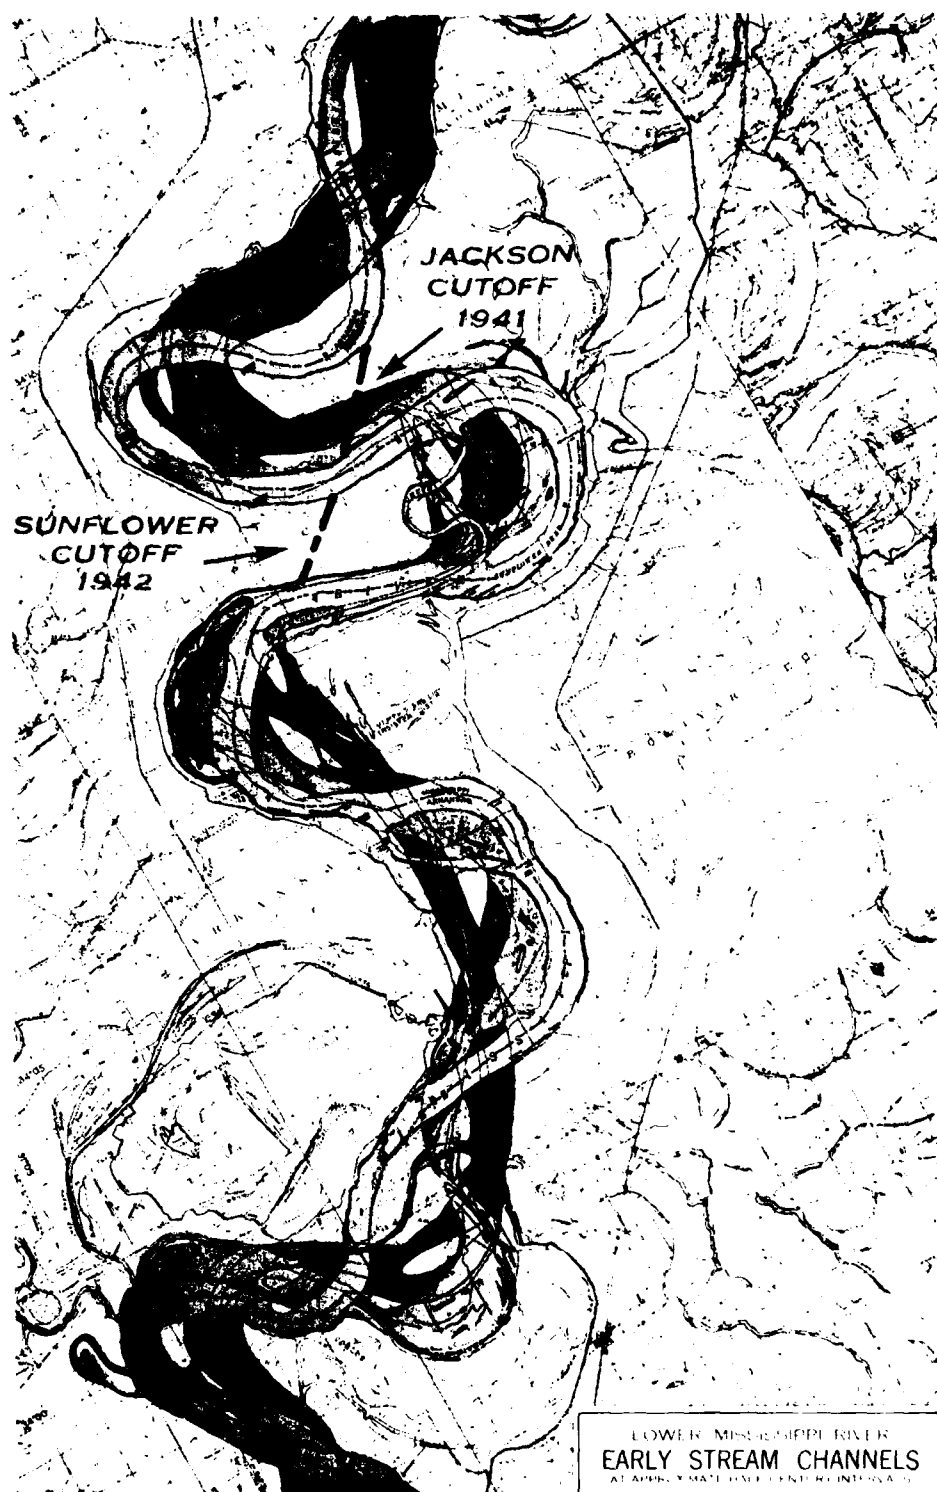
Figure 14

HISTORIC DEVELOPMENT OF THE JACKSON POINT-SUNFLOWER REACH

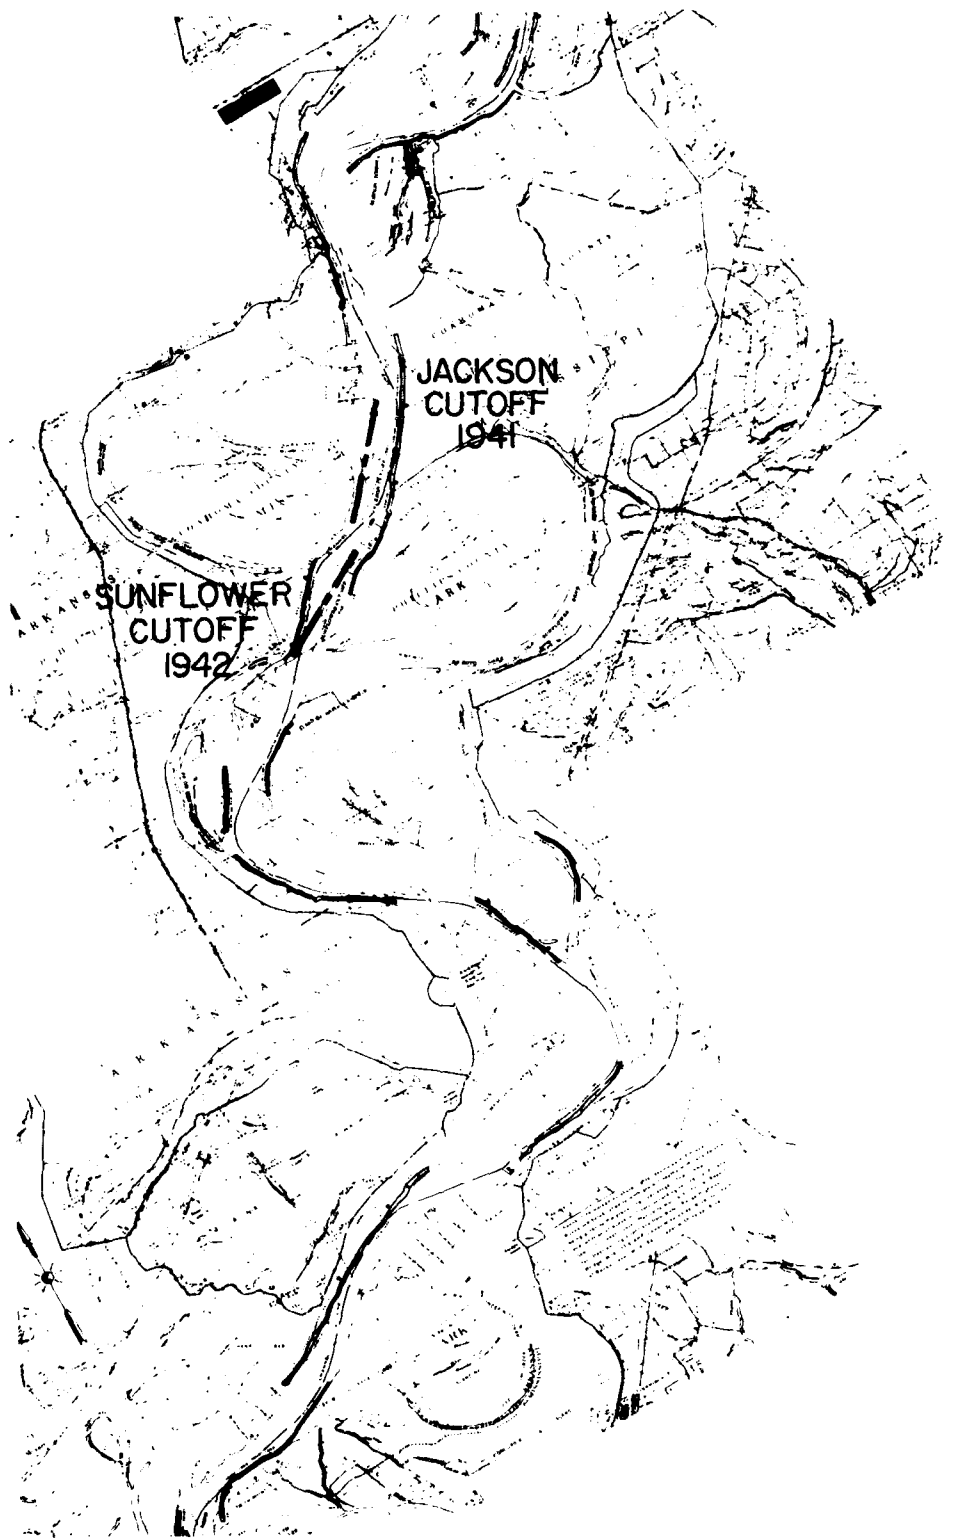
Figure 15

1975 MISSISSIPPI RIVER IN THE JACKSON POINT-SUNFLOWER REACH

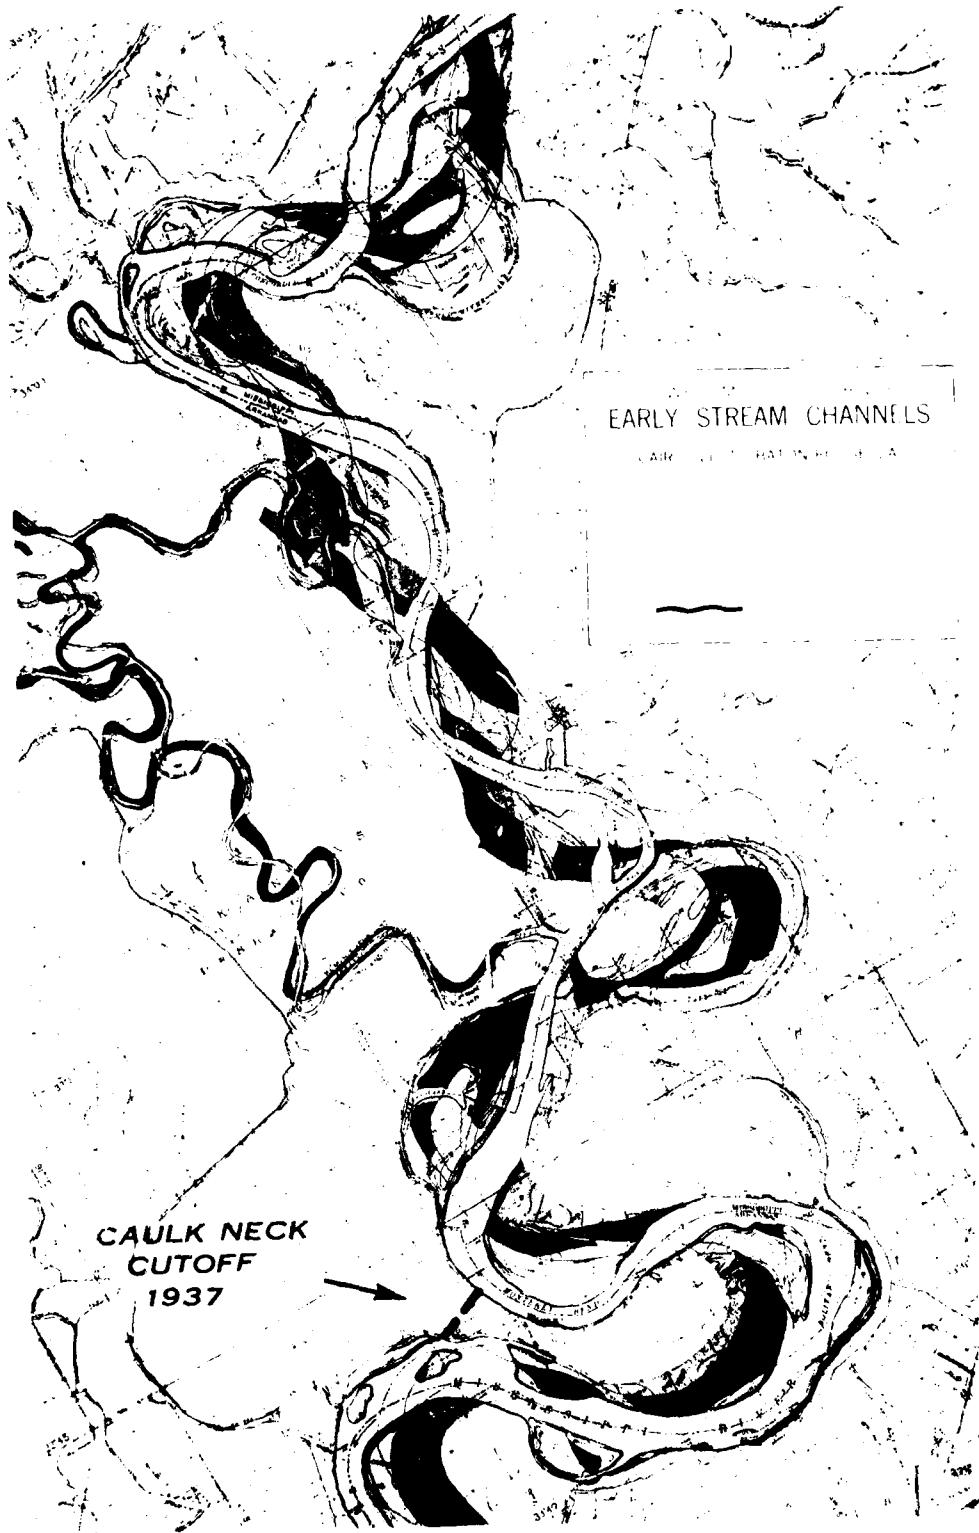
Figure 1

HISTORIC DEVELOPMENT OF THE CAULK NECK REACH

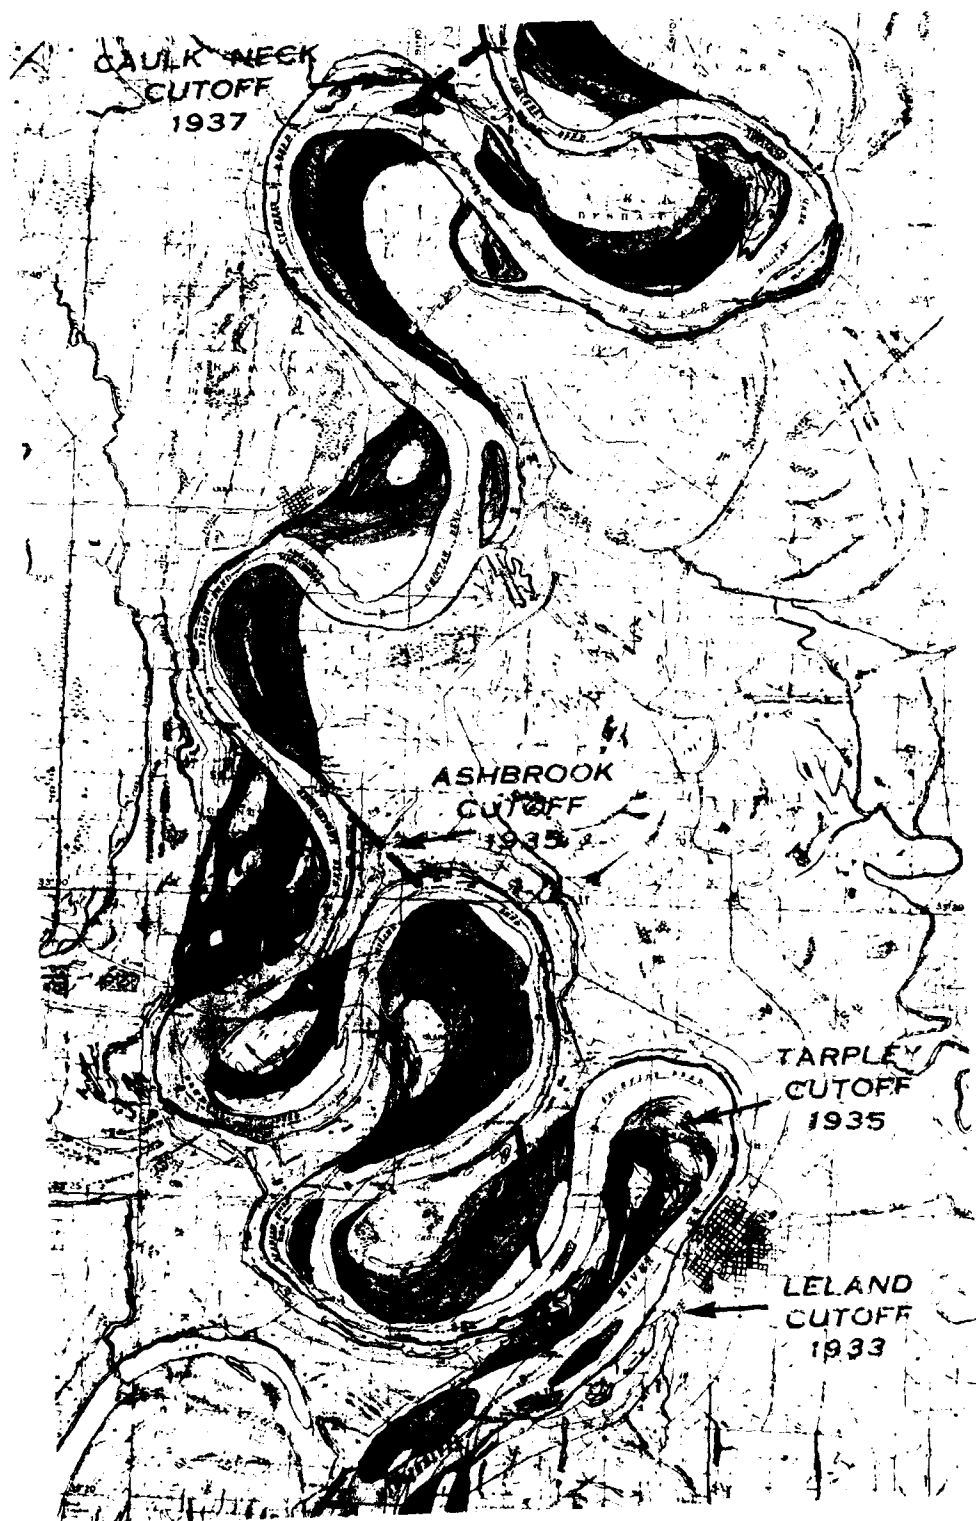
Figure 11

HISTORIC DEVELOPMENT OF THE GREENVILLE REACH

Originally, General Ferguson³ planned only two cutoffs in the Greenville Reach, but a natural cutoff at Leland Neck (Figure 21) forced a last minute alteration of plans. Matthes⁷ states in a communication to W. E. Elam⁶ of Greenville, Mississippi, in September 1940:

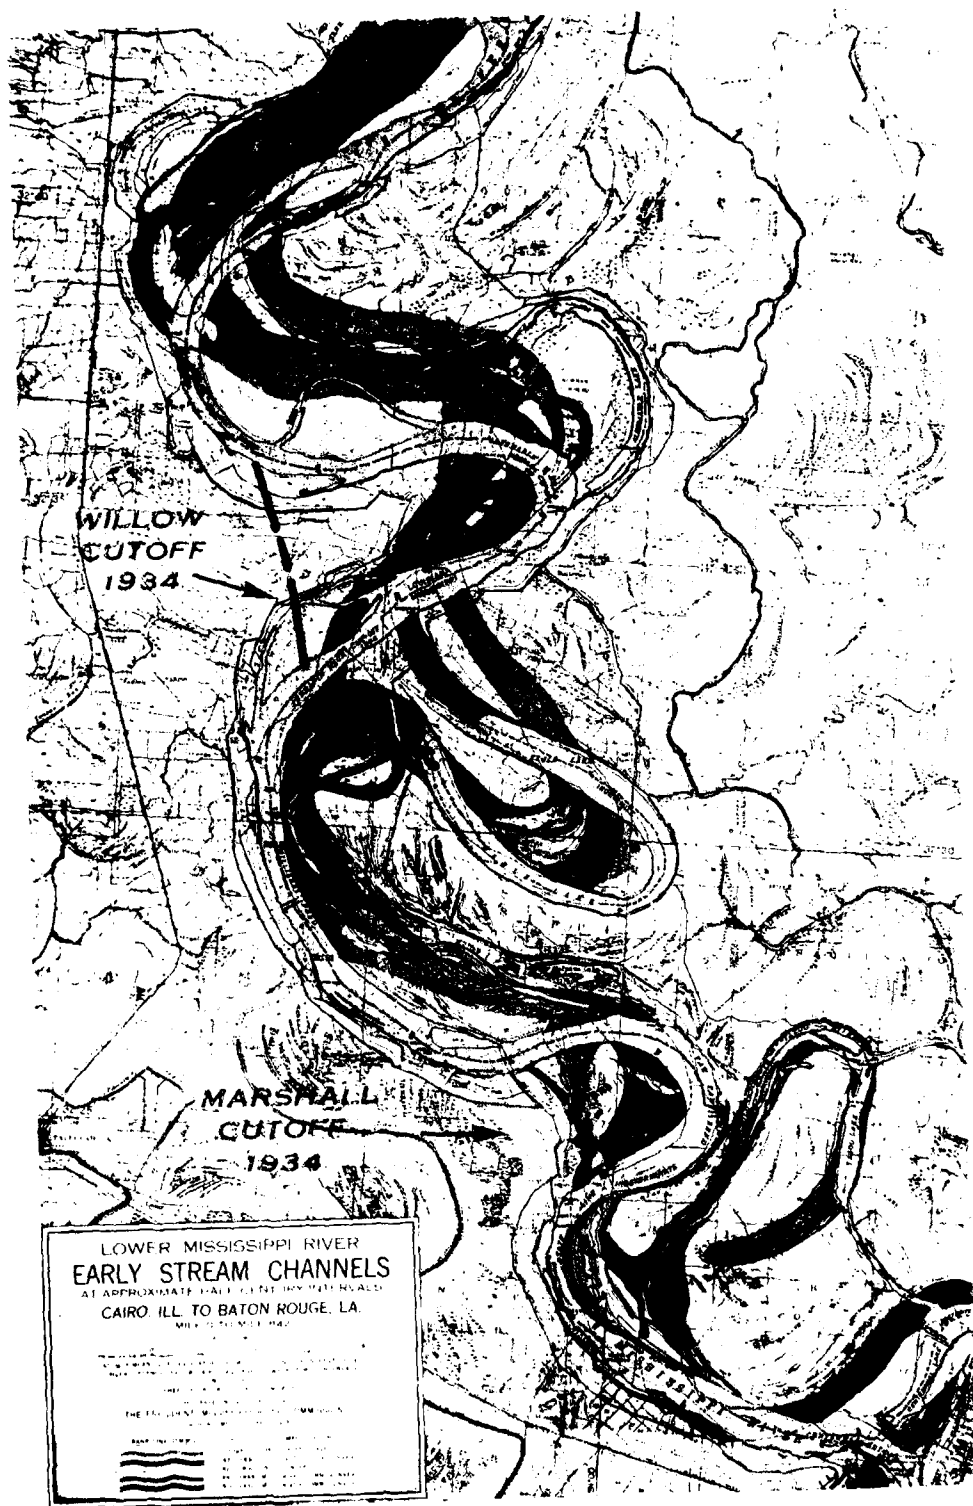
HISTORIC DEVELOPMENT OF THE WILLOW POINT AND MARSHALL POINT REACHES

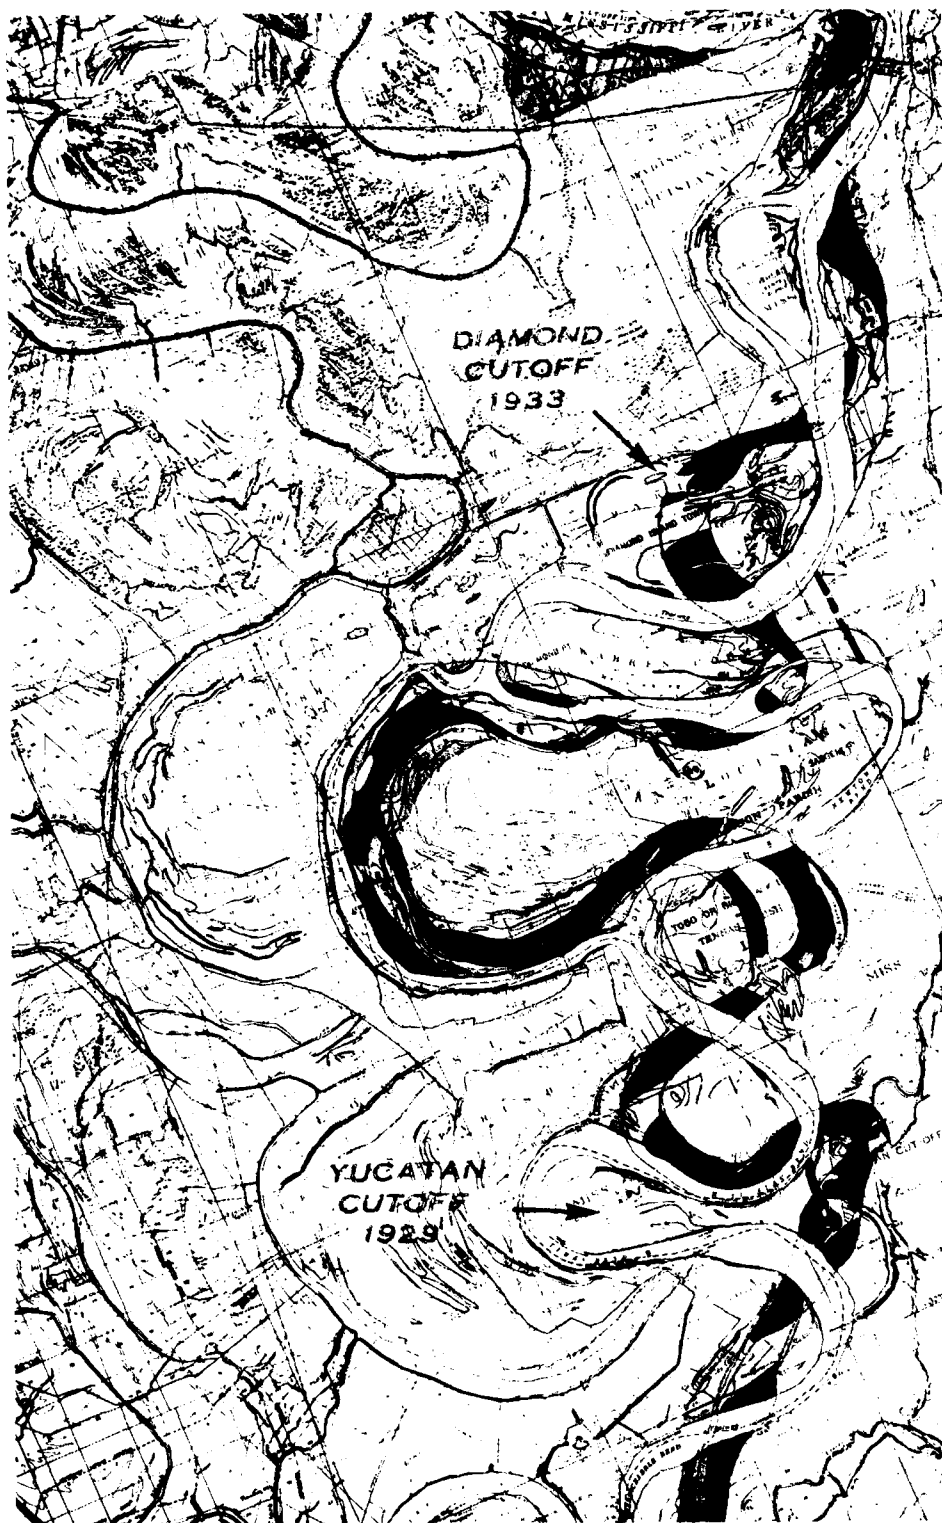
Figure 33

HISTORIC DEVELOPMENT OF THE DIAMOND POINT
AND YUCATAN REACHES

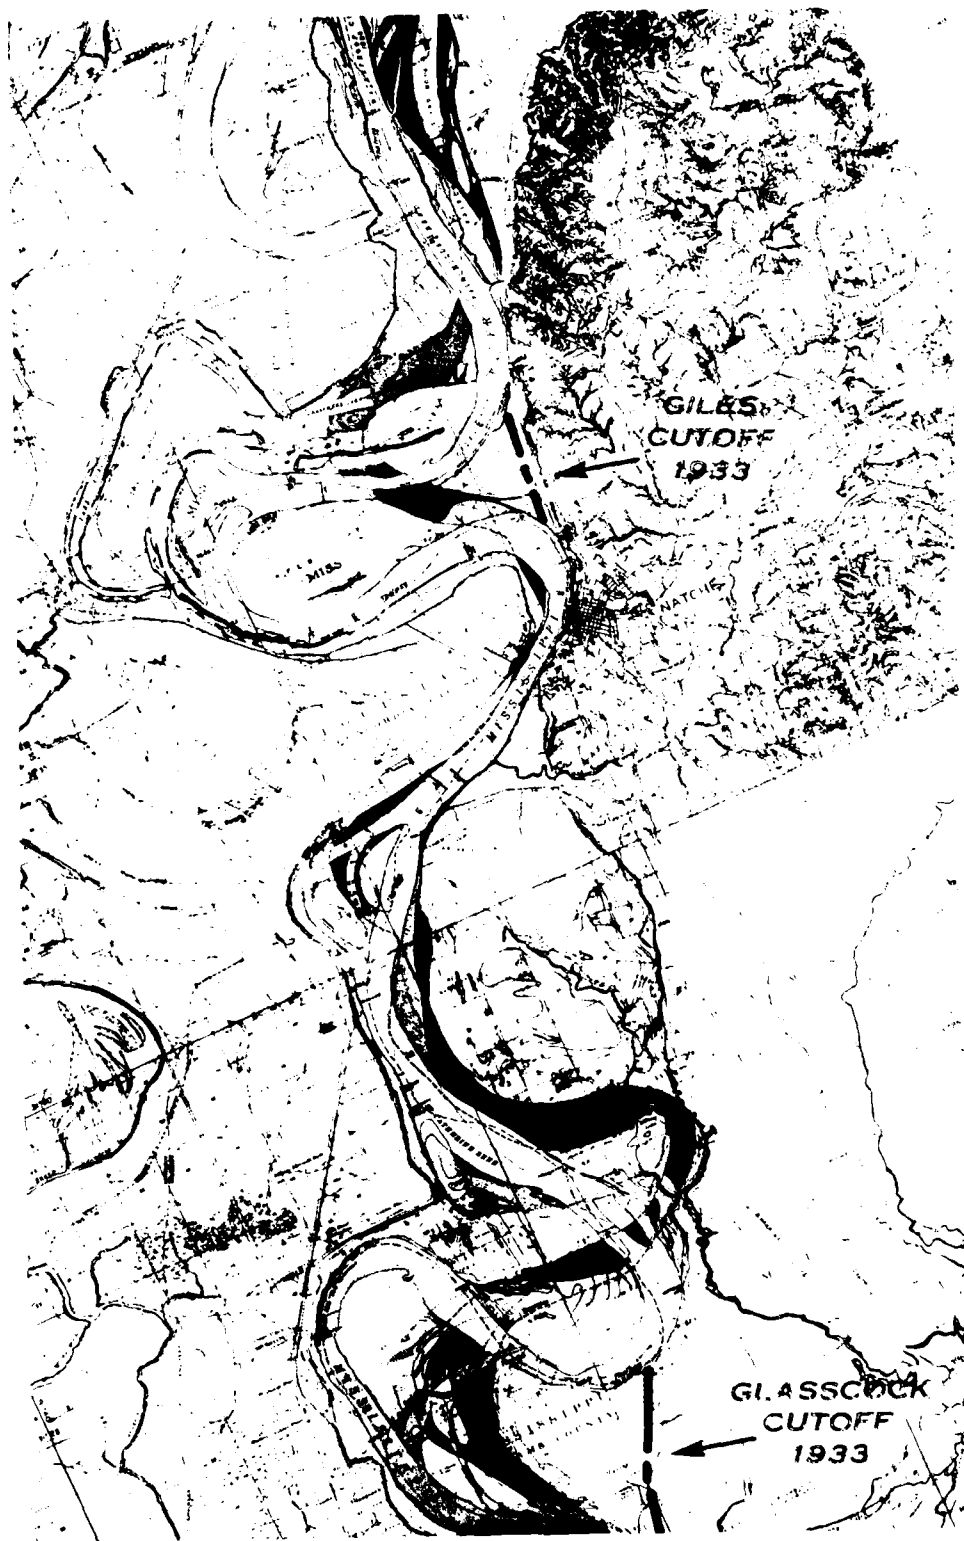
Figure 30

HISTORIC DEVELOPMENT OF THE GILES REACH
